1756 ControlLogix Controllers, Revision 17

ControlLogix Controller Catalog Numbers

1756-L61, 1756-L62, 1756-L63, 1756-L64, 1756-L65

This publication describes enhancements and anomalies (known and corrected) for ControlLogix controllers, revision 17.

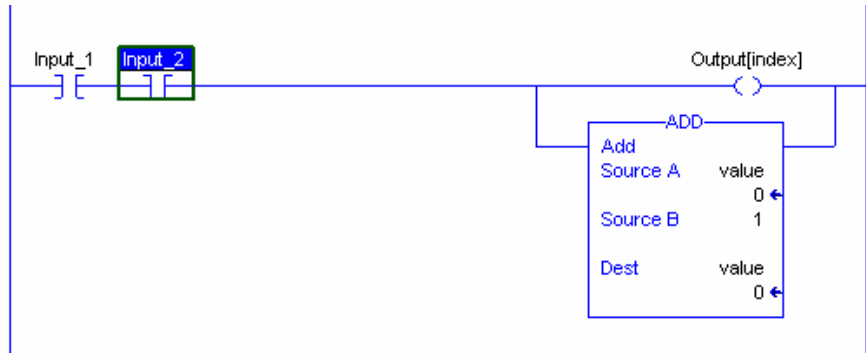
Cat. No.	Firmware Revision	Description
1756-L55Mxx, 1756-L61, 1756-L62, 1756-L63, and 1756-L64	17.04	<p>Fault handlers can be defined at the controller and program scope levels. These fault handlers are typically used to handle major recoverable faults that can occur during runtime execution of an application due to programming errors. A typical example of this would be handling indirect addressing that has gone out of range; MyTag[index], where index is larger than the size of the array.</p>
1756-L61S, 1756-L62S, 1756-L63S	17.08	<p>Faults can also be handled by the controller during pre-scan of the controller program on the transition to Run mode. Again, for example, the handling of indirect addressing that has gone out of range.</p> <p>There is an anomaly when these methods attempt to handle a fault.</p> <p>These are the possible ways the anomaly can manifest itself:</p> <ul style="list-style-type: none"> • The controller will experience a major non-recoverable fault. I/O goes to their configured safe state, and the user application is cleared from memory. At this point, a Code 1 Type 60 or 61 major recoverable fault will be logged in the controller. This requires you to redownload the application. • Tag data corruption. • Online saving or uploading failures. • Anomalous program execution. <p>For example, if a rung is being scanned false and there is an instruction that has false execution, the fault handler executes so the remainder of the rung will scan true. In the example below, the OTE instruction has an index out of range. After returning from the fault handler, the ADD instruction will execute, even though the rung input conditions are false.</p>

<p>Lgx00106482, Lgx00100765, Lgx00097014</p>
